PHASE I REPORT  
NATIONAL DAM SAFETY PROGRAM  
TENNESSEE

Name of Dam ..... Crystal Lake

County ..... Hardeman

Date of Inspection ..... February 23, 1981

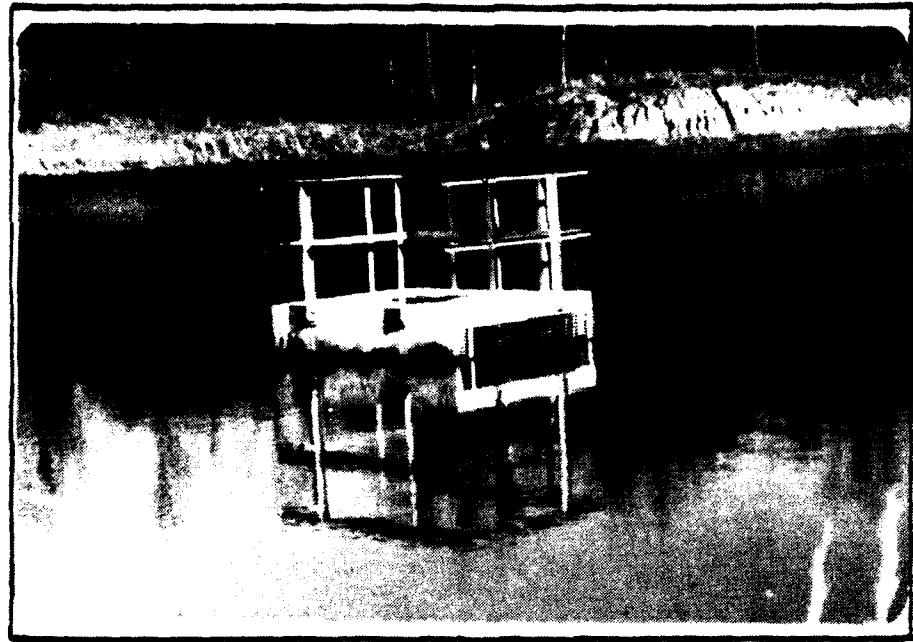
PHOTO NO.3

Photo No. 3 - The service spillway riser.

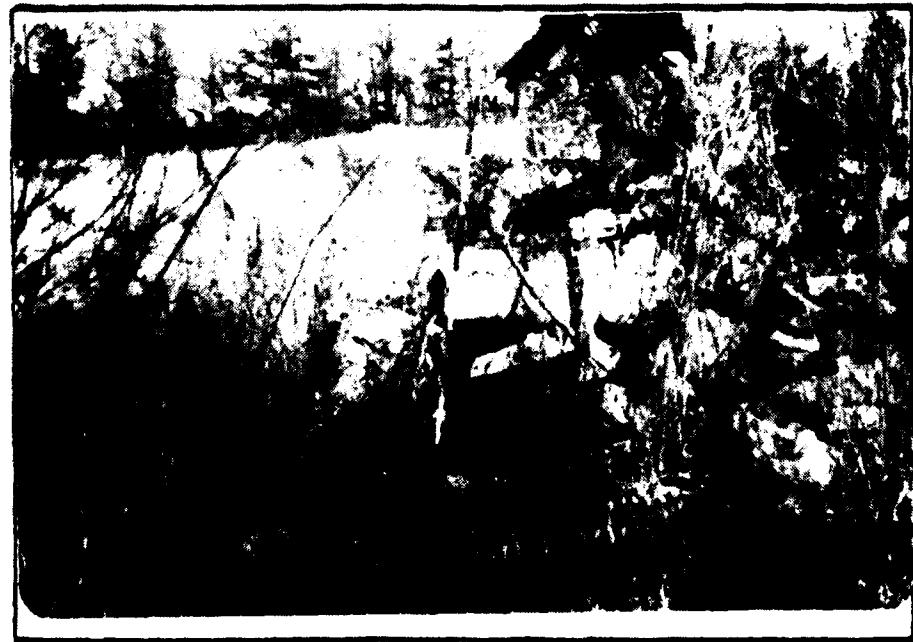
PHOTO NO.4

Photo No. 4 - The outlets of the service spillways and toe drains.

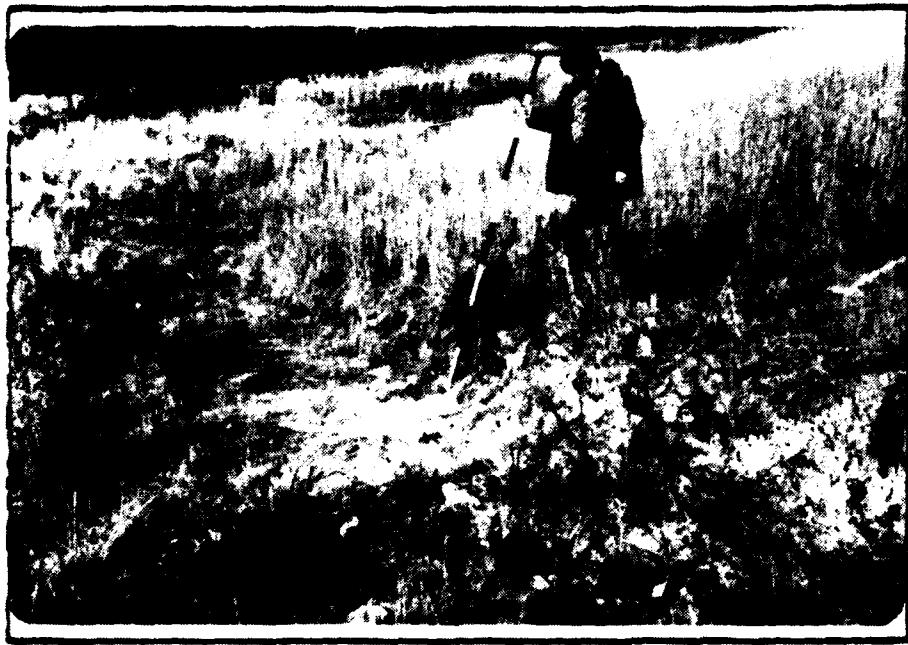
PHOTO NO.5

3.1.9 A 6-8" vertical drop was found near the toe of the embankment above the service spillway pipe. The drop appears to be a mechanical cut possibly due to the use of earthmoving equipment near the toe.

Photo No. 5 - A discontinuity on the downstream slope near the toe and slightly to the right of the service spillway outlet. The feature was apparently produced by earth moving equipment.

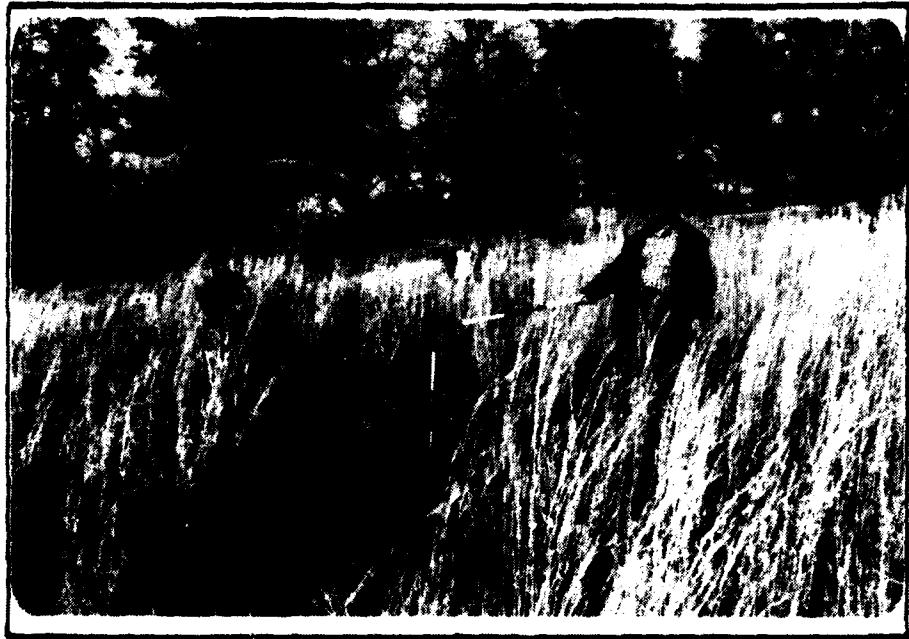
3.1.2 A seep or spring is emerging on the right downstream embankment abutment contact about one foot below the pool elevation the day of the inspection. A slight flow (less than 1 gpm) is coming from the seep, but there is no indication of the transport of embankment material. The flow is beginning to erode a gully along the right downstream embankment abutment contact (photo nos. 9 & 10).

e. The seep or spring on the dam appears to be groundwater and does not appear to present any immediate hazard to the structure.

Photo Nos. 9 & 10 - A seep or spring on the right embankment abutment contact starting about one foot below the pool elevation.

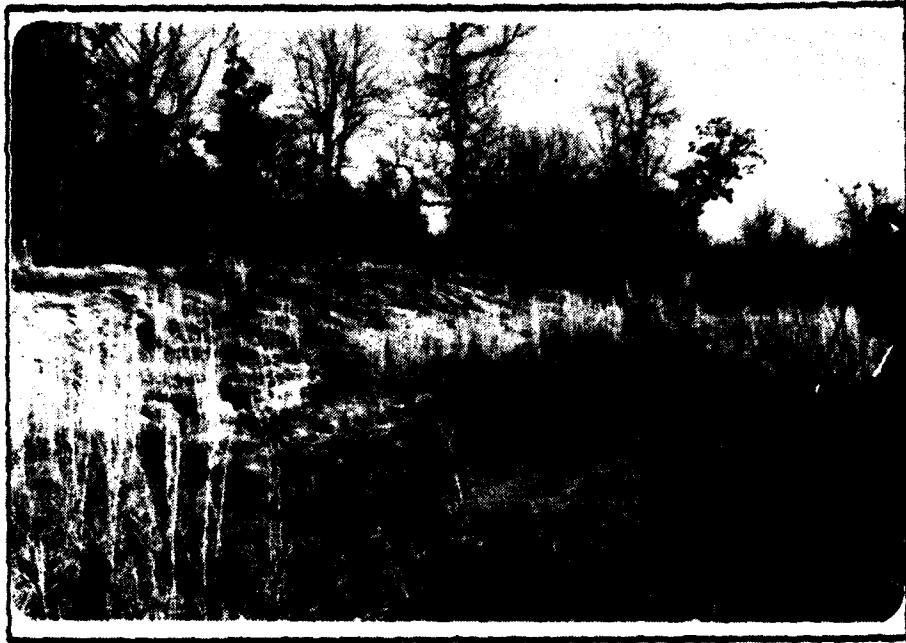
3.1.3 The emergency spillway is undergoing an excessive amount of erosion. Material washed from the side slopes has filled the control section to the point that the effective depth of the channel is only 0.6'. Gullies have formed in both the entrance and exit channels (photo nos. 11 & 12).

Photo Nos. 11 & 12 - The emergency spillway channel showing the sparse vegetation and excessive erosion of the side slopes.
